## **Cultural Landscape Inventory for Picatinny Arsenal, New Jersey**

Final report

Under Project Number 396911, "Cultural Landscape Inventory for Picatinny Arsenal"

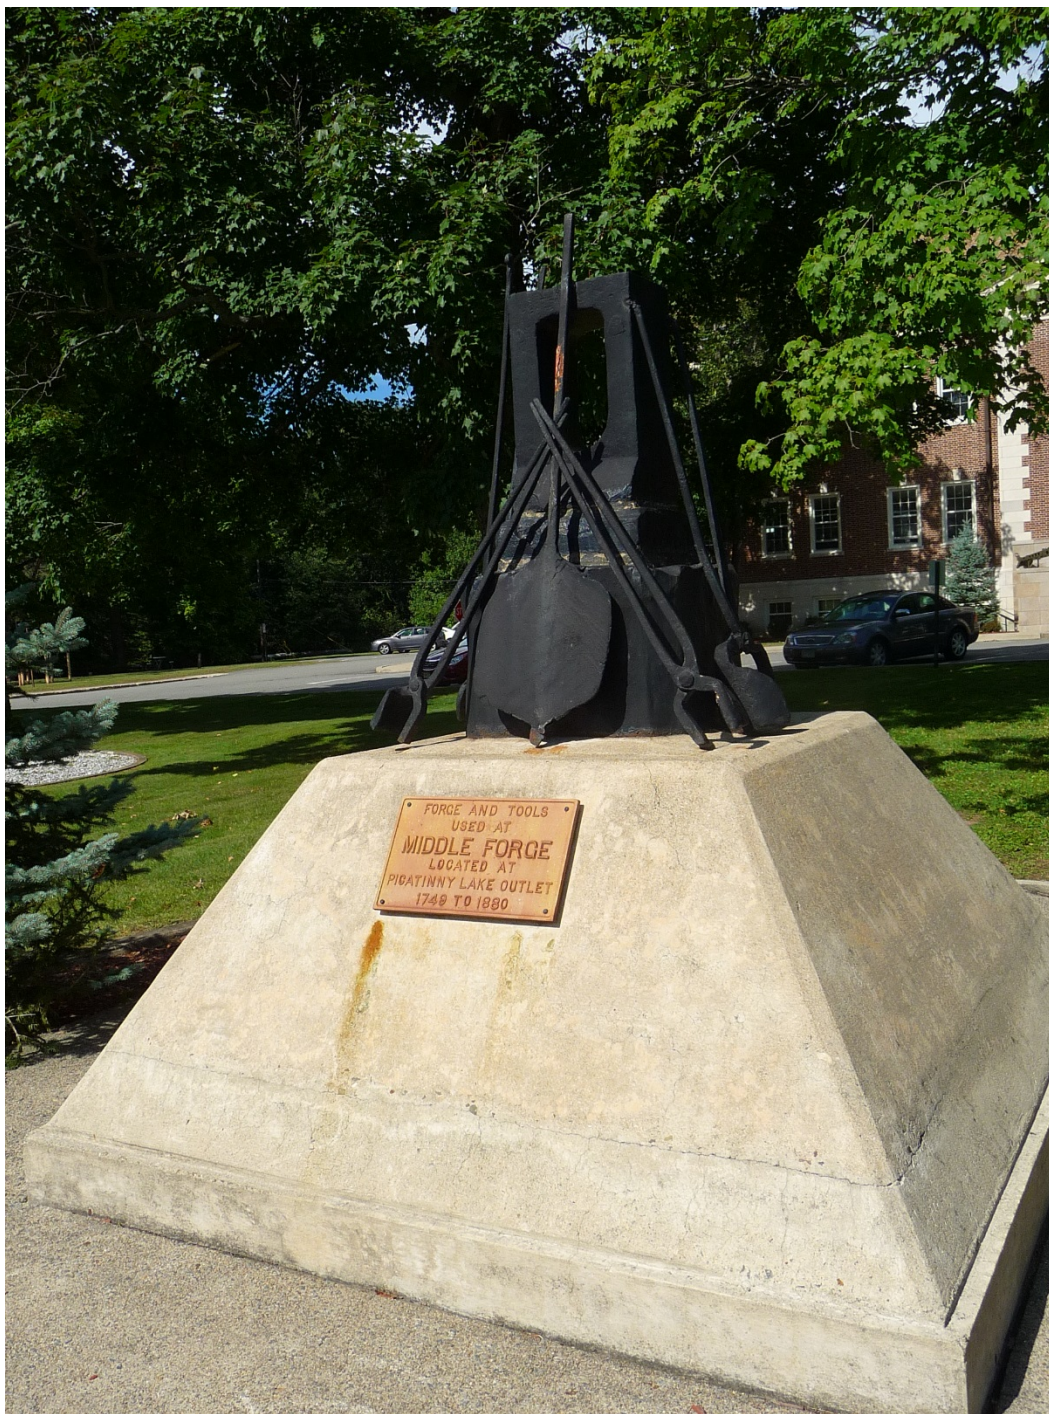
Figure 3. Middle Forge Monument (Monument 151M), located in front of Building 151 (ERDC-CERL, 2013).

The iron industry in New Jersey was a profitable one from 1804 to 1816, but the depression in 1820 caused a downturn. The decade from 1830 to 1840 was again profitable for iron makers. A technological change in the process in 1837 introduced a hot blast process, which reduced the charcoal needed by one-half. A stone coal manufacturing process led, however, to the ultimate cessation of iron forge works in general. At the height of its operation, the Middle Forge reportedly employed 60 men and produced 10–20 tons of iron per week (Figure 2). The forge trip hammer (with a 14-inch square face and weighing 600 pounds) and the anvil (two feet square and weighing an estimated 4,000 pounds), along with other forge tools are on exhibit at Picatinny Arsenal (Figure 3, Monument 151M).

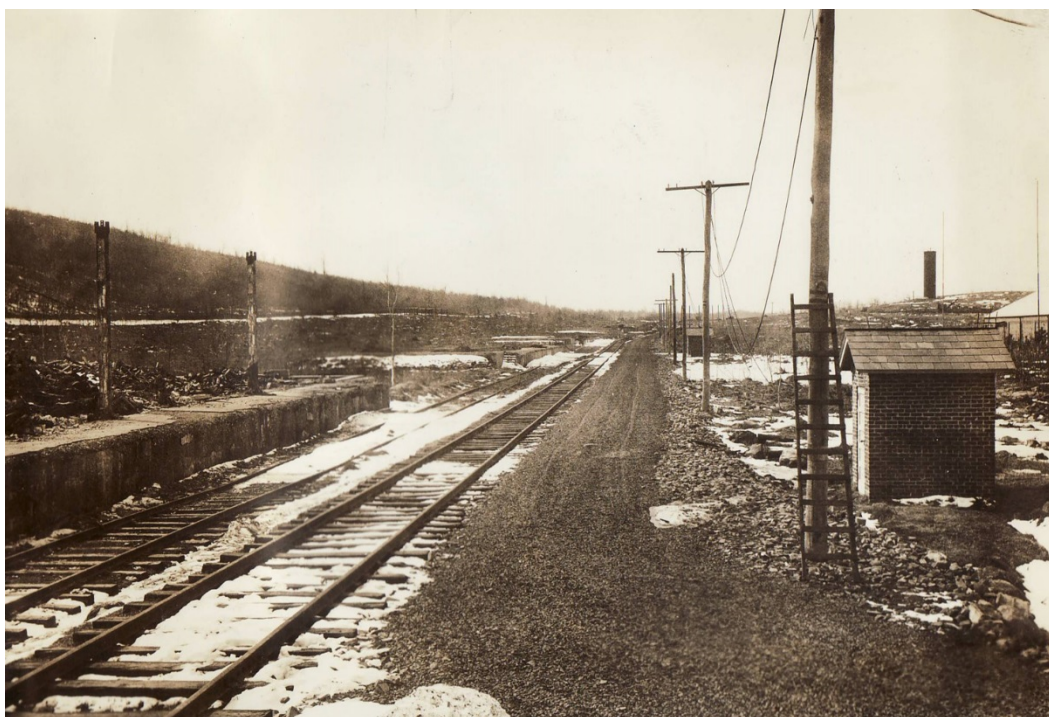
Figure 6. Foundations of missing magazines C-40 and C-41 after road improvement, circa 1934 (NARA 71-CA-212 Lake Denmark Folder).

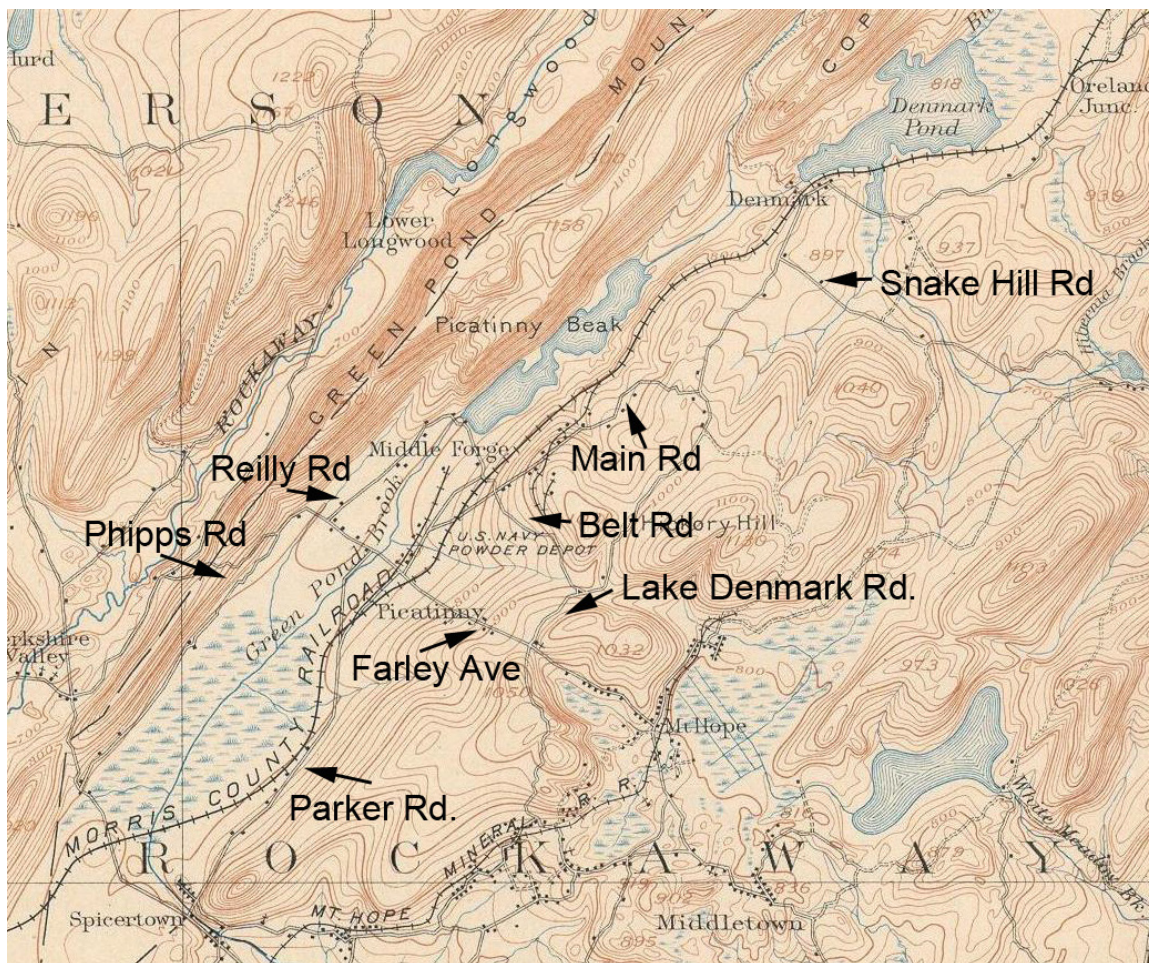
Figure 10. 1905 map of Picatinny Arsenal with historic roads marked (PICA Cultural Resources).

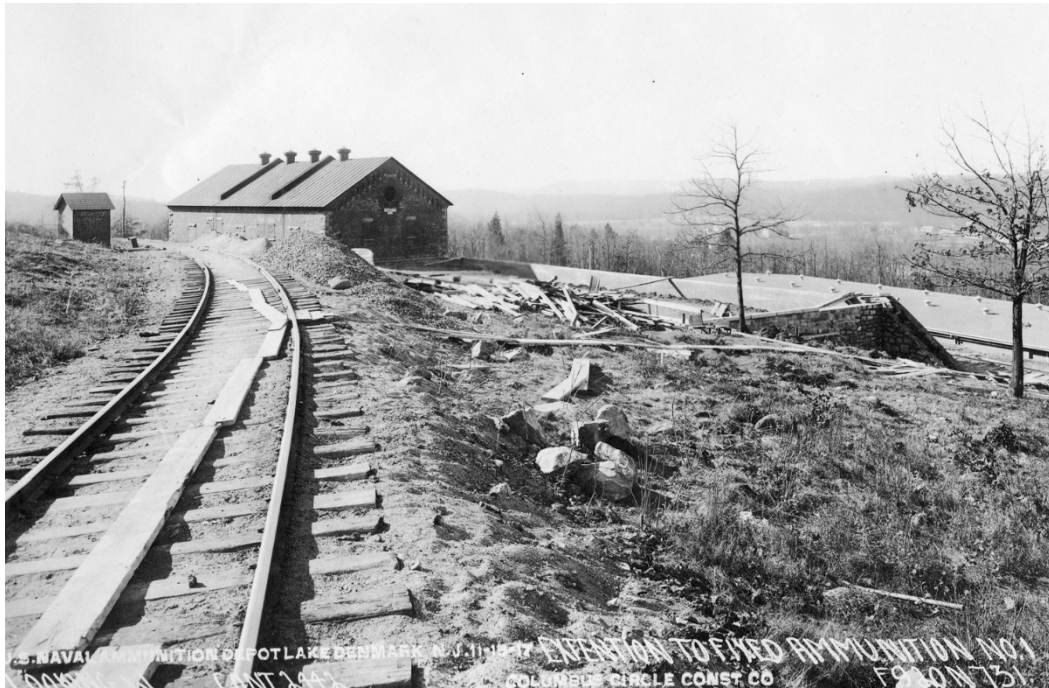
Figure 15. Railway in front of Fixed Ammunition No. 1, 1917 (National Archives and Records Administration [NARA] 71-CA-212 Lake Denmark Folder).

The railroad system was a vital part of the mission at Picatinny, with track covering the largest area during WWII (Figure 14–Figure 17). After the war, the requirement for such extensive track lessened. In 1964, Picatinny undertook an extensive rehabilitation of the Arsenal’s railroad system, and more than 21 miles of track were restored, reconstructed, or under consideration for reconstruction. Three railroad bridges (Bridges 11, 12, and 13) and a turnout were replaced, and slightly more than three miles of abandoned track were removed. Some abandoned tracks became the bed for walking and jogging paths (Nolte 1999a, 103). Most of the rail lines were removed in 1979, with the exception of those near the main gate (Rae 1999, 14).

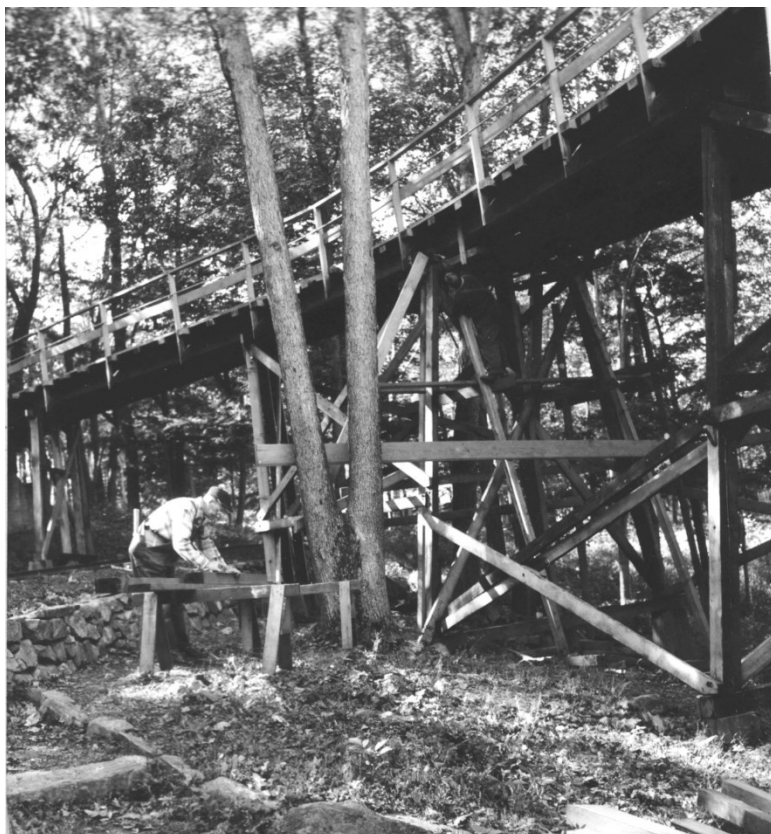
Figure 16. Repair of narrow-gauge railway trestle near Building 559, circa 1940s (PICA History Office).

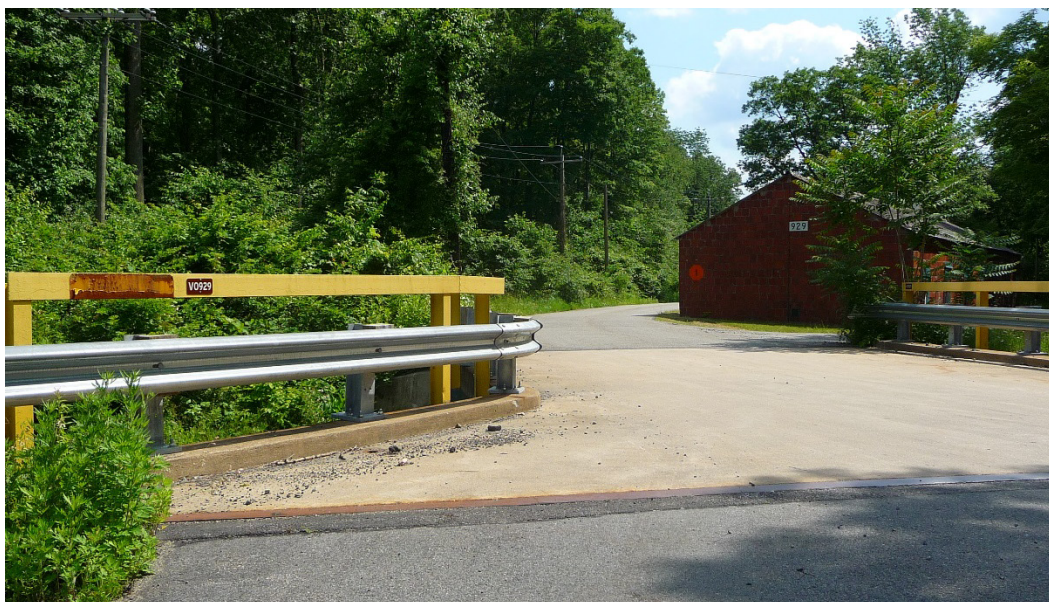
Figure 19. Vehicular Bridge V0929 in front of Magazine 929 (ERDC-CERL, 2013).

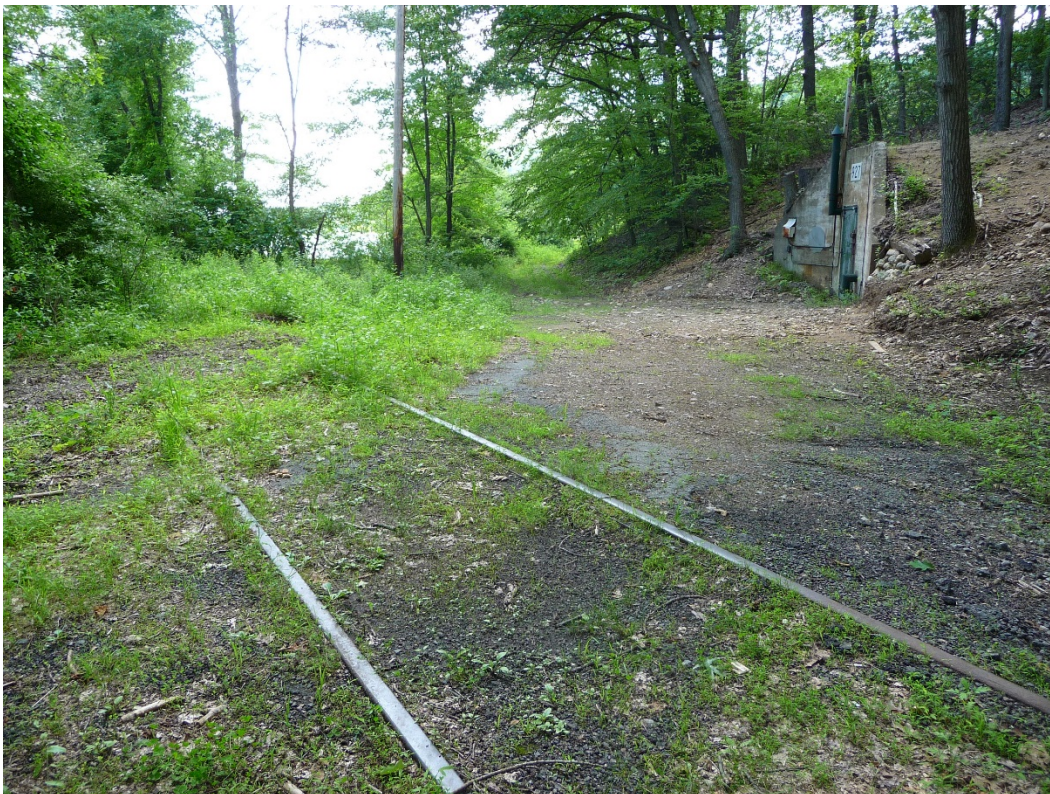
Figure 27. Building 927, magazine (ERDC-CERL, 2013).

This magazine area (e.g., Figure 26 and Figure 27) is located east of Picatinny Lake. Built during 1918–1920s, these magazines were constructed to store materials necessary for the production of explosives but were later adapted for

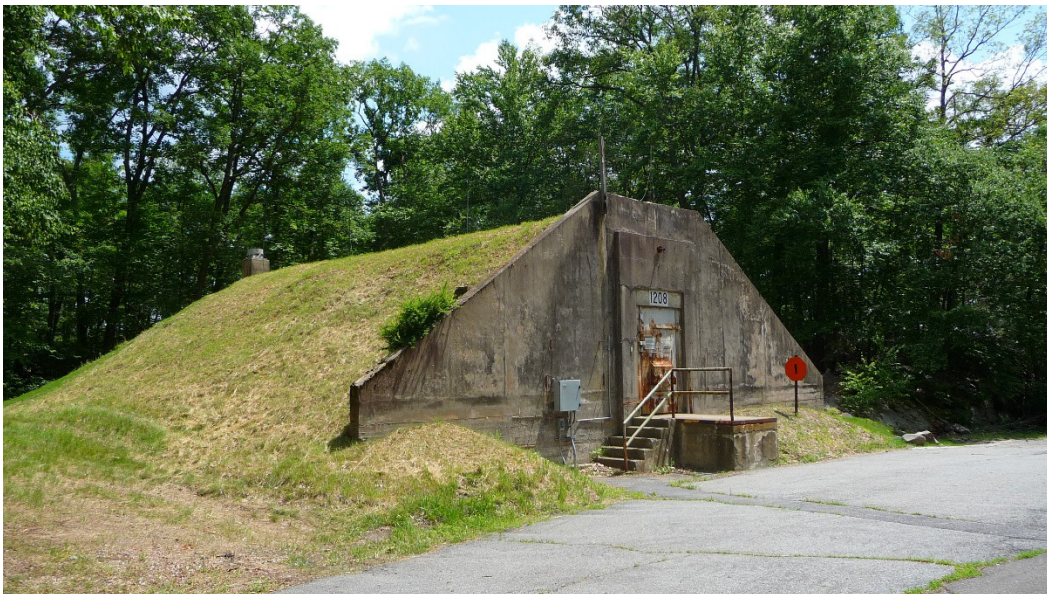
Figure 28. Building 1208, storage igloo (ERDC-CERL, 2013).

This magazine area is located north of Lake Denmark as an igloo storage area which was built at the end of WWII. Two new igloo storage buildings were constructed among the historic and fit into the landscape (Buildings 1215 and 1216). These storage buildings (Figure 28 and Figure 29) were found not eligible in a 1999 architectural survey (Nolte et al. 1999a, 40).

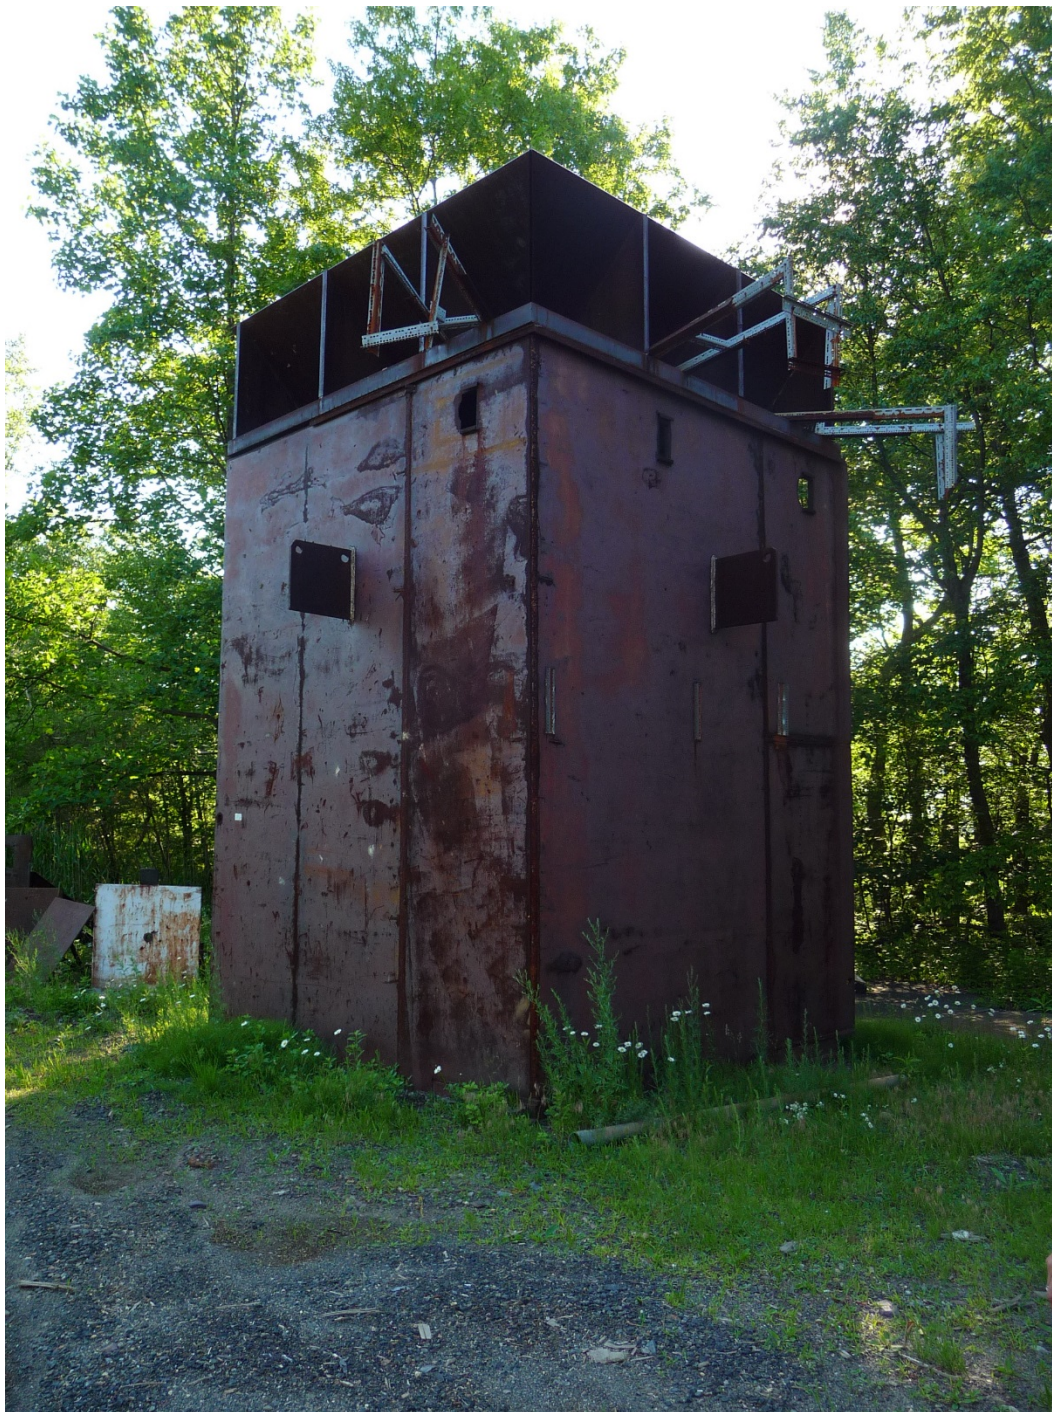
Figure 49. Test firing structure at Test Area 670 (ERDC-CERL, 2013).

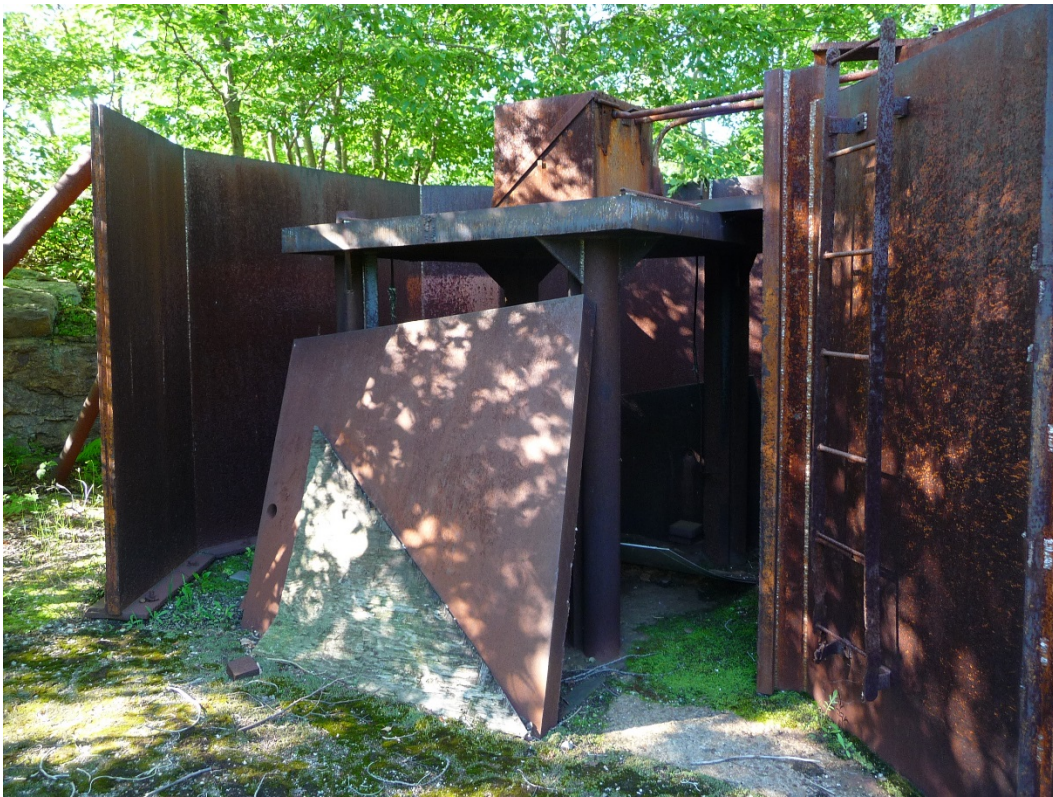
Figure 58. Rear of firing structure, Building 649 (ERDC-CERL, 2013).

Building (or Structure) 649 is listed as an Ordnance Facility Barricade located in Bear Swamp Area #3. This building was listed as “not found” on the 2007 Panamerican study due to overgrowth in the area (Nolte et al. 2007, B-8). Built in 1953/1957, it is listed as not eligible to the NRHP. Site features include Building 649, entrance road, parking area, and many moveable test firing structures (Figure 56–Figure 60).

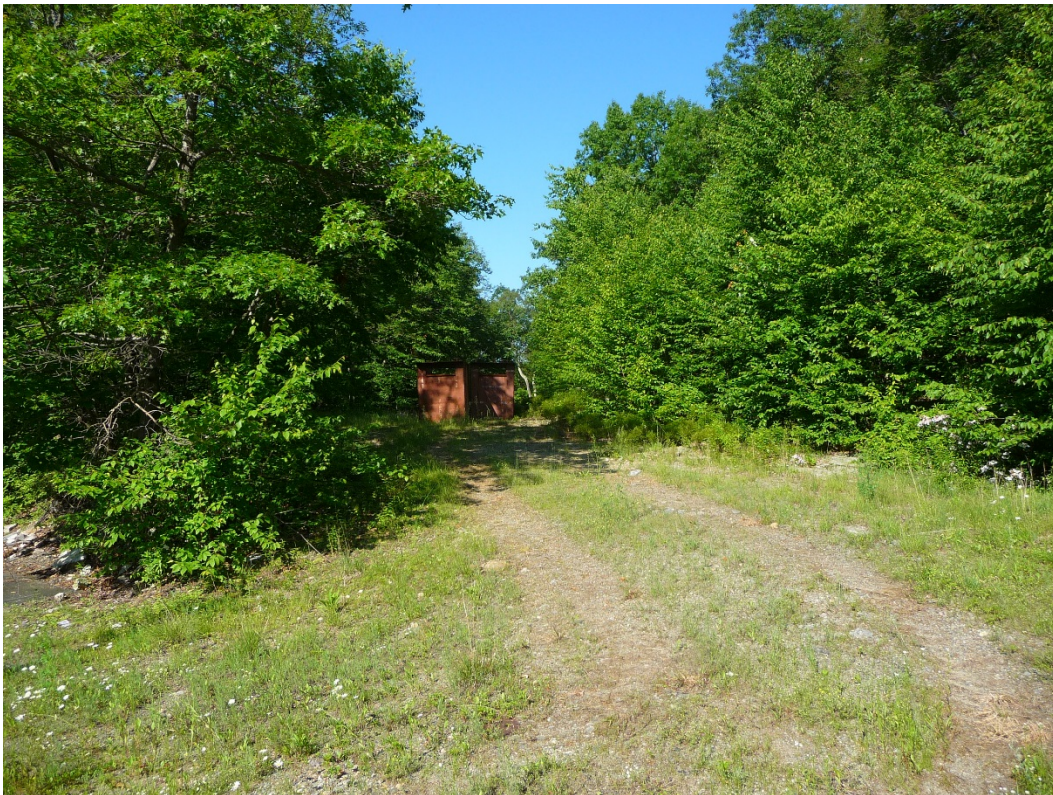
Figure 72. Firing structure at Test Area 1 (ERDC-CERL, 2013).

area (Figure 70–Figure 74). A structure has been proposed as a covering for the firing area itself since 2009, but has yet to be funded or built. A previous report found Building 616 to be lacking architectural or historical significance (Nolte et al 2007, 4-69). Therefore, the landscape is not significant either.

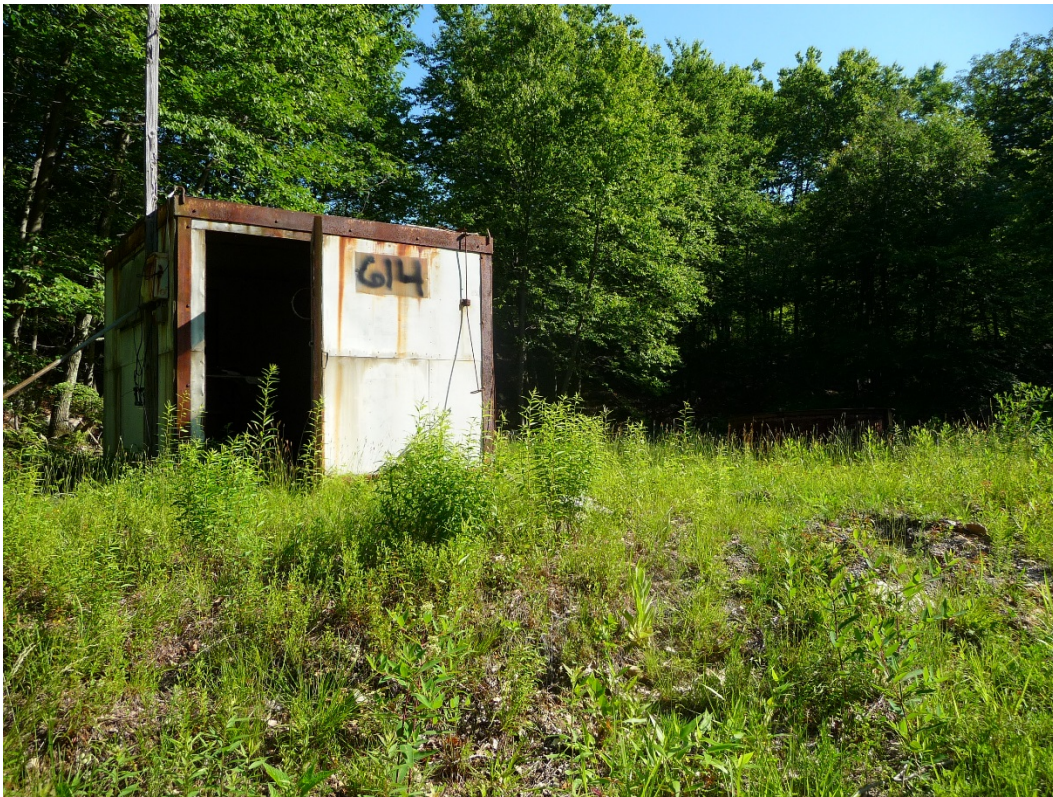
Figure 80. Unnumbered firing structure (ERDC-CERL, 2013).

Off James and Greenburg Road is an unnamed test area. Landscape features included Buildings 611C, 614, and 615 (until they were demolished in 2015 per the RPMP FRP PA) and an unnumbered firing structure (Figure 78–Figure 82). Building 614 was previously used as a general purpose warehouse, and Building 615 was an ordnance facility and fire control brigade turret. Both were built in 1958. No information was found on 611C. A previous report found the buildings in poor condition and lacking architectural or historical significance (Nolte et al 2007, 4-69). Without these original buildings, the landscape has no integrity.

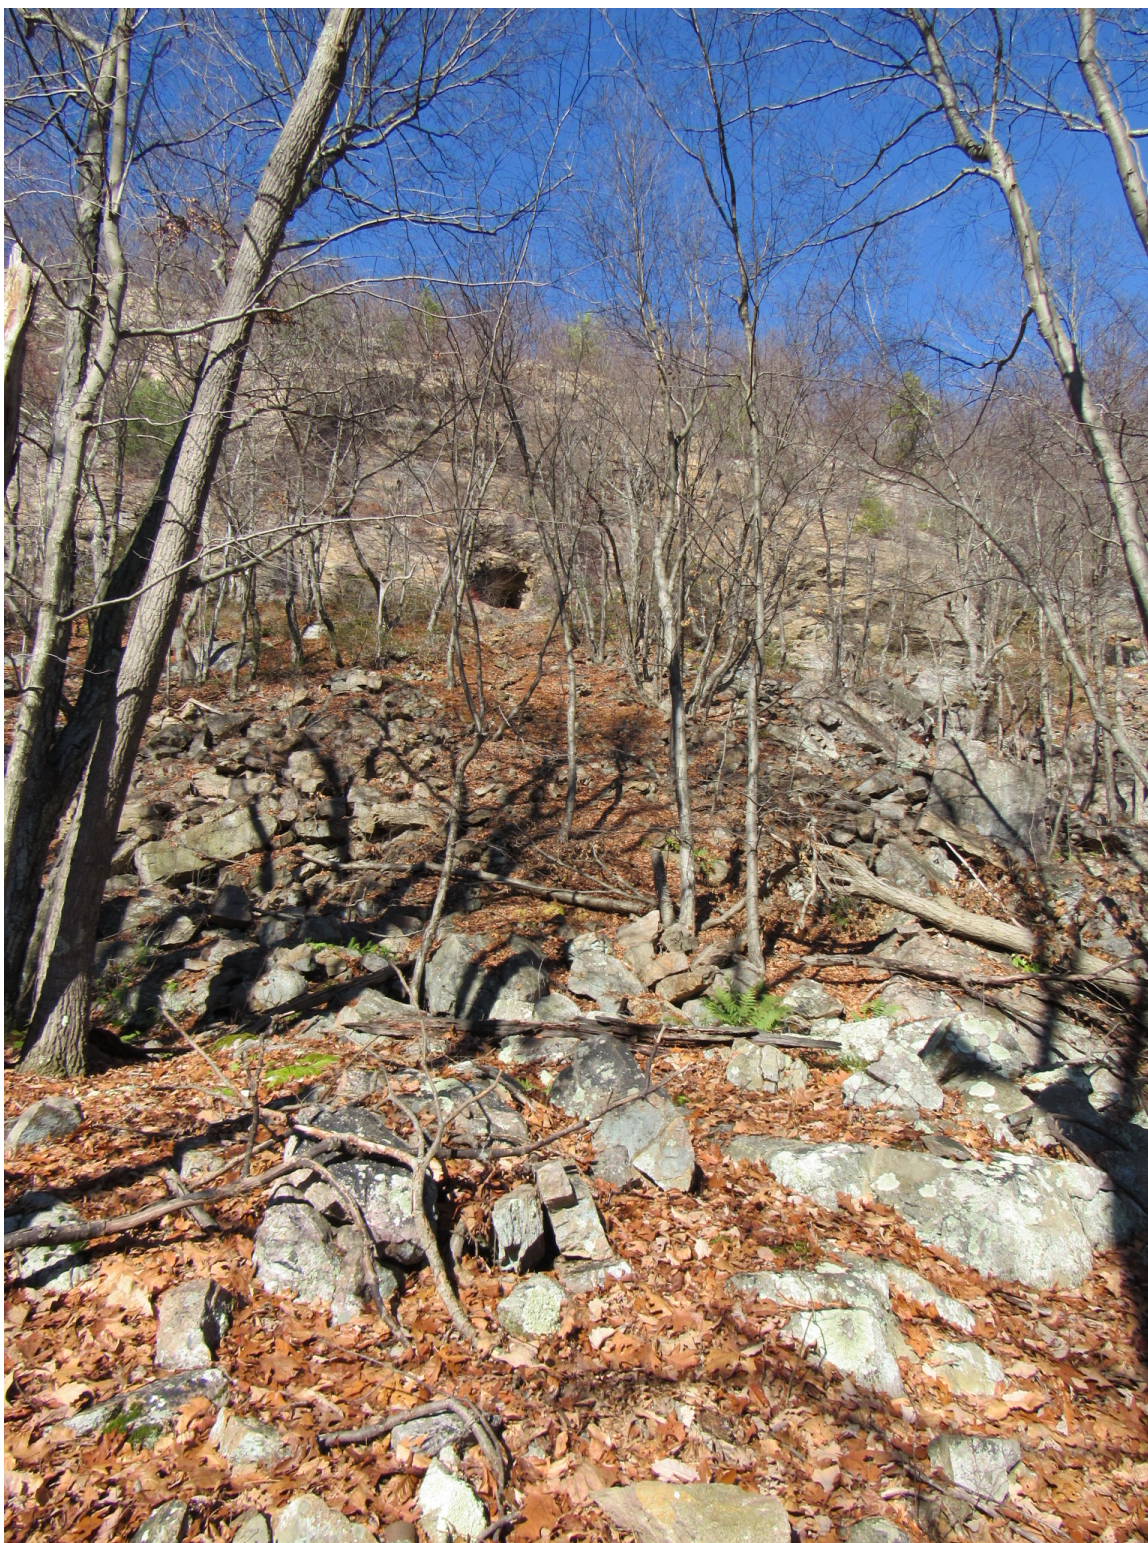
Figure 110. Photograph of man-made cave used for firing (PICA Cultural Resources, 2015).

Also located just west of this area, is a man-made cave that Picatinny created in the 1920s when they used to fire ammunition rounds into the mountainside from the old Proving Grounds that was located in the 500 Area (Figure 110). This practice was discontinued after the 1926 explosion when all test areas were contained on the 600 Hill and the Gorge. Noted on a 1920/1922 map, the cave can be seen from Building 3013 along Navy Hill during the winter season when the leaves are off the trees.

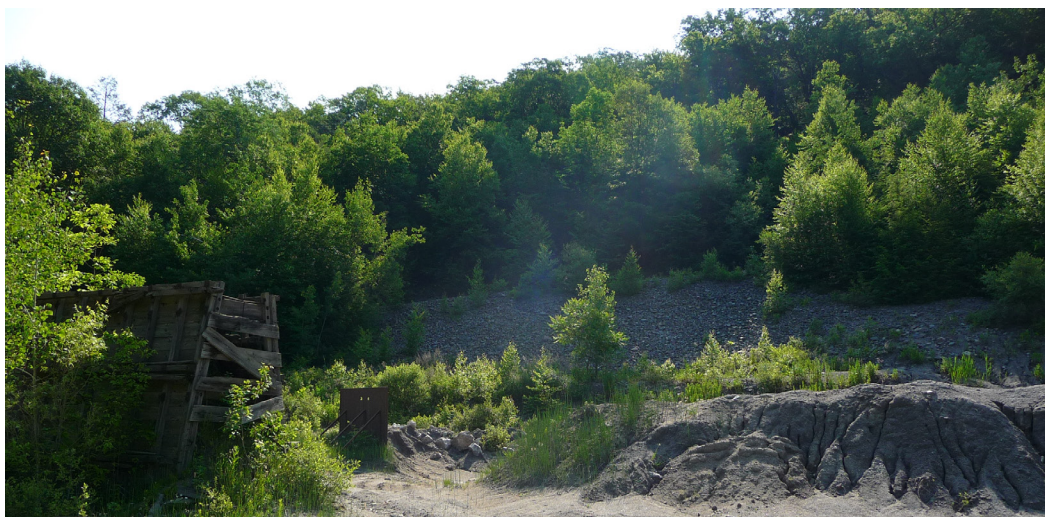
Figure 116. Blast wall on left (ERDC-CERL, 2013).

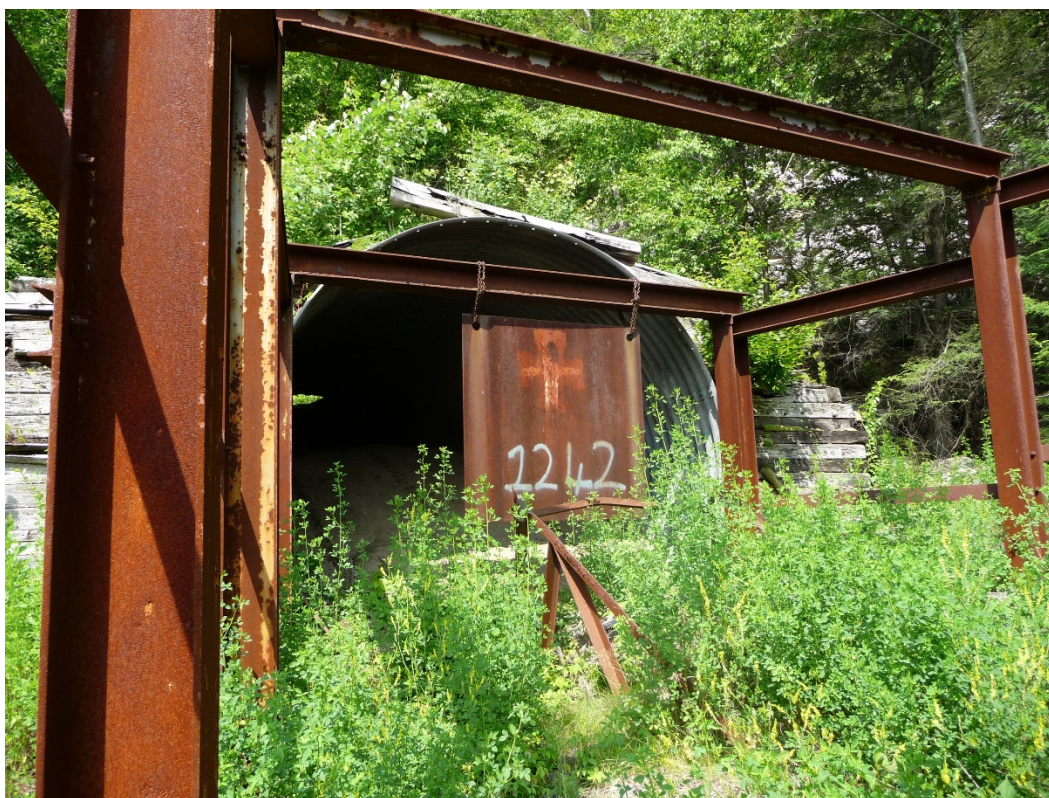
Figure 124 Target butt, Building 1242A (ERDC-CERL, 2013).
